MUNDY TOWNSHIP

Windfield Estates Subdivision

Road Repair Estimate

April 28, 2014

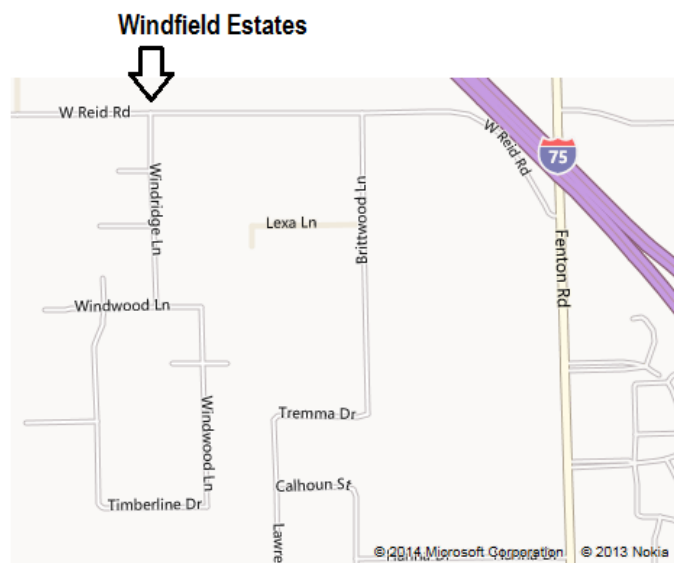
Pavement condition throughout the subdivision varies from deteriorated to fair. It appears that the newer phases are in much better condition. In many cases this is due not only to the pavement being newer but that it has experienced less construction traffic throughout the life of the pavement.

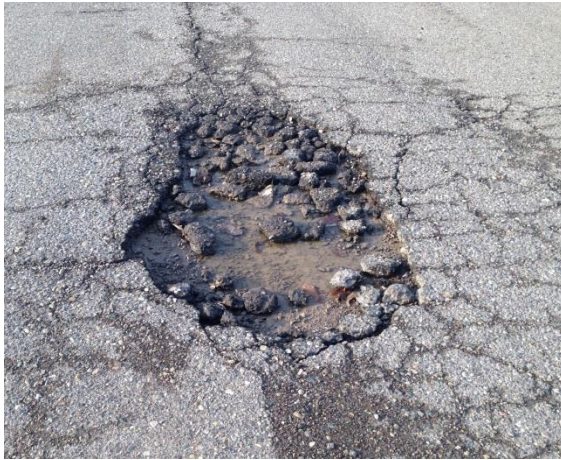
There are several areas with holes in the pavement located throughout the subdivision. The pavement in these exposed areas, as shown below, appears to only be a couple of inches thick. It is recommended that pavement cores be taken throughout the project limits to determine the existing thickness of the pavement and underlying material. This information will also help us determine the best method for repair for the project.

Pavement is ~2" thick

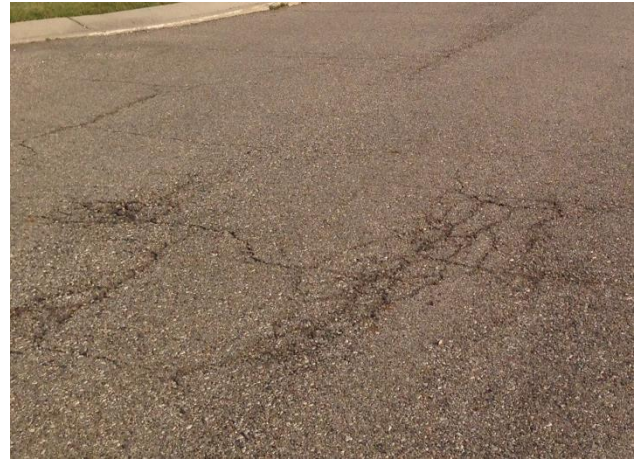
Existing cracks, but pavement is staying together

In many areas, it is clearly visible whether the existing pavement is in need of repair or not. In other areas, the proposed fix is not so obvious. Areas with existing cracking including severe alligator cracking, as shown above, will be closely inspected. We have found on past projects that if the cracks are holding together, the existing pavement can be salvaged and placing an overlay will extend the pavement life. However, there is a good chance that larger cracks will come through the overlay in a short period, if not fixed. With the overlay option, preventative maintenance on the pavement should be expected much sooner than with a reconstruction. Once the cores have been taken, we will be able to determine the existing pavement thickness. If the pavement is thick enough, surface milling in areas is proposed to help remove the existing cracking. In areas where the pavement is to remain, the existing pavement will need to be cleaned and tack coat placed prior to placing the top layer of HMA.

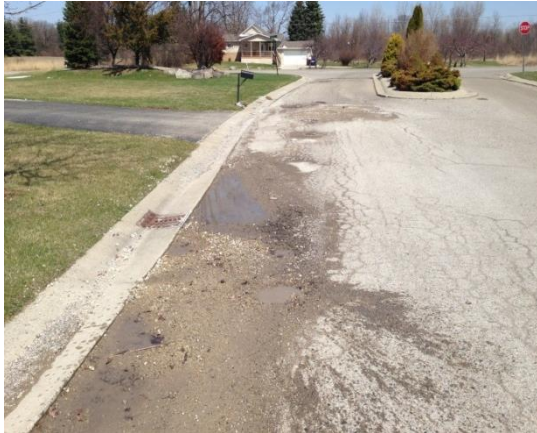
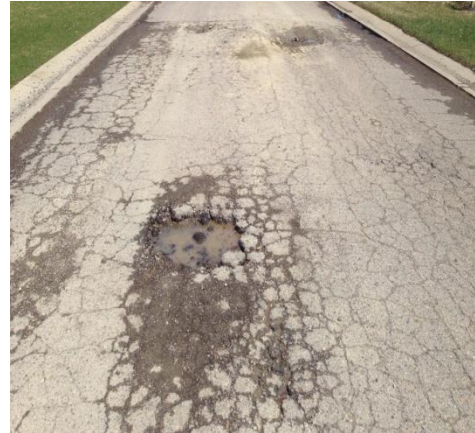
This roadway is most likely the first roadway that was built. The majority of this roadway is in very poor shape with several potholes and HMA cracking throughout. The uneven pavement and blow outs in the roadway may also indicate that there are subbase or subgrade issues below HMA surface. Drainage is also

questionable along this roadway, and there are several sinking areas next to catch basins and storm crossings that are heaving.

Areas in need of reconstruction and possible undercutting

Proposed Improvements: It is recommended that this entire roadway be removed and reconstructed with the proposed aggregate base and pavement section. Once the pavement has been removed, the subgrade should then be inspected to determine if any undercutting is needed. Storm repairs are also needed throughout including reconstruction near the basins. We also propose to place subgrade underdrain in this section to help facilitate the drainage of the underlying base material.

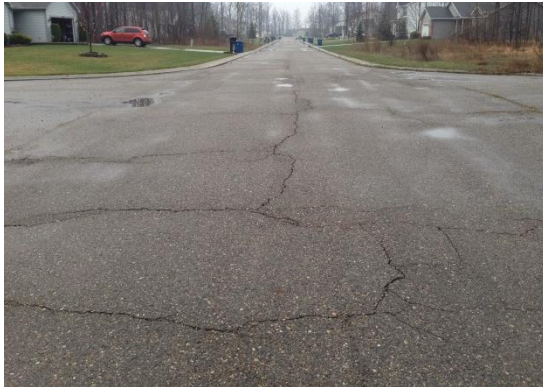
Repair Area - Cracks are starting to separate

Proposed Improvements: It is proposed that the intersection of Windridge Lane and Windwood be removed, undercut, and replaced. Moving to the east, this section of roadway will also need to be removed and replaced. The section that runs north and south will be a combination of pavement repairs and HMA overlay. West of Windridge Lane, the roadway will be overlaid along with a few pavement repairs. Storm sewer repairs will also be needed throughout. Subgrade underdrain will be placed in areas where it can be tied to a catch basin.

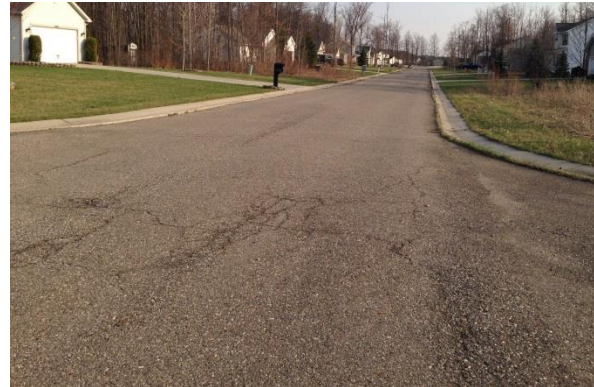
Overlay Area

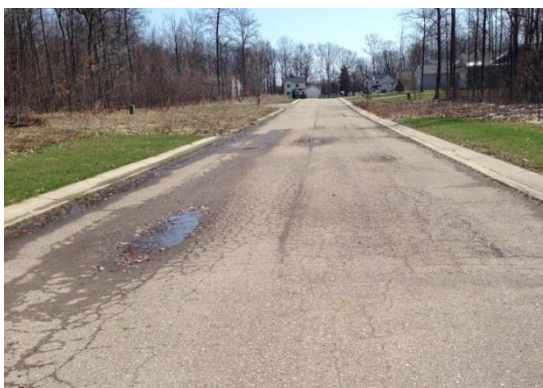
The section of Timberline Drive that extends east and west is in poor shape. This is especially true on the west end in the lower lying area that may be surrounded by wetlands, indicating the possibility of poor underlying soils. The pavement in this section is wavy and rutting in areas which may also be an indicator of poor underlying soils. The section of roadway extending north and south is in better condition except for at a few drainage crossings that are flooding and holding water. These areas are south of Dellmont Drive and south of Windwood Lane. Drainage should be evaluated throughout, especially in these areas.

Reconstruct Area

Proposed Improvements: The section of roadway extending east and west is proposed to be removed, undercut in areas, and replaced. The section that runs north and south will be a combination of repairs and

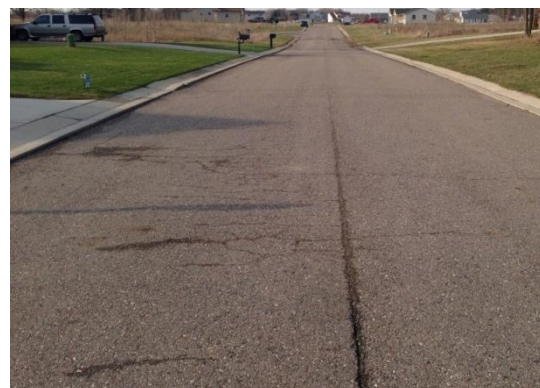
Repair and overlay area

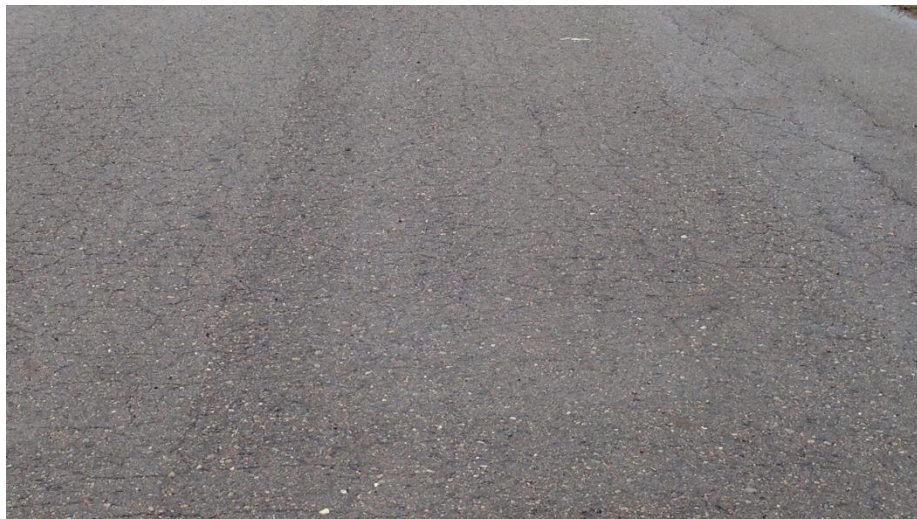
Dellmont Drive appears to be in fair condition and may be a newer roadway. The existing surface has several cracks but seems to be holding together. The intersection of Dellmont Drive and Timberland Drive is in poor condition. The existing storm should be evaluated throughout this roadway.

Extensive alligator cracking, but still holding together

Proposed Improvements: We recommend that the intersection of Dellmont Drive and Timberland Drive be reconstructed. The remainder of roadway is proposed to be overlaid along with a few pavement repairs, if needed. Storm sewer repairs will be proposed, as needed.

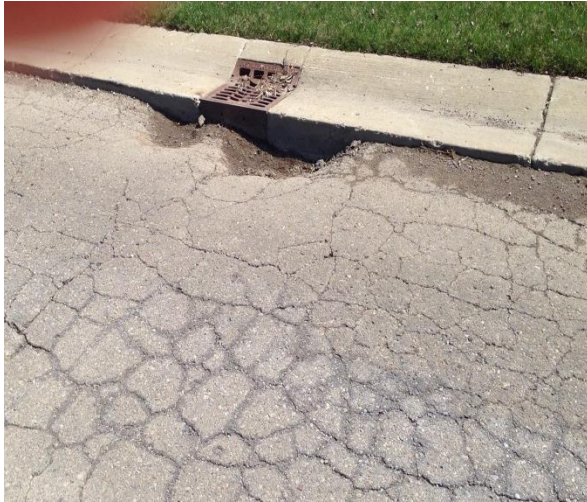
Each of the existing catch basins should be evaluated in detail to determine conditions and needed repair. There are several areas in which the roadway next to the curb and gutter has sunk which may indicate that the catch basin is siphoning the underlying base material creating failure. Poor compaction with the original construction is also a possibility. This can be seen in the picture below. In the areas where failure is visible, the surrounding pavement will need to be removed, fill material placed, and properly compacted. Assuming proper compaction was completed, many times during construction the contractor will leave out a brick or a hole which will allow the water to drain until the top course of HMA has been placed. The structures may just need to be repaired or pointed up. During design, all structures throughout the subdivision should be evaluated.

Pavement sinking near structure

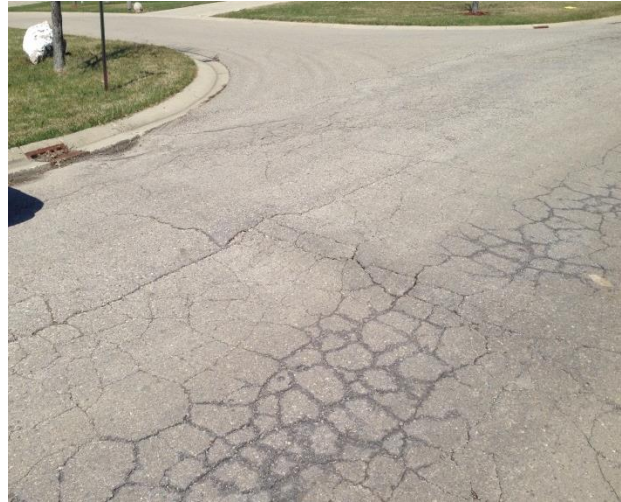
The storm crossings within the roadway should also be evaluated. In several cases, the roadway shows extensive cracking along with sinking or heaving at the crossings, as shown in Picture #2. This is often a sign of poor compaction around the pipe. Each crossing should be evaluated to ensure the integrity of the pipe. ROWE proposes to use our Quickview camera to take a look inside the pipe. At a minimum, if the pipe is in good condition the pavement should be removed, the material around the pipe properly compacted, and then the roadway reconstructed.

Heaving cross culvert
